STATEMENT OF DEFICIENCIES AND PLAN OF CORRECTION		(X1) PROVIDER/SUPPLIER/CLIA IDENTIFICATION NUMBER:  <b>HAL080007</b>	(X2) MULTIPLE CONSTRUCTION A. BUILDING: 01  B. WING _____	(X3) DATE SURVEY COMPLETED  R <b>02/04/2015</b>
NAME OF PROVIDER OR SUPPLIER  <b>HERITAGE CENTER</b>		STREET ADDRESS, CITY, STATE, ZIP CODE <b>2809 OLD CONCORD ROAD SALISBURY, NC 28146</b>		
(X4) ID PREFIX TAG	SUMMARY STATEMENT OF DEFICIENCIES (EACH DEFICIENCY MUST BE PRECEDED BY FULL REGULATORY OR LSC IDENTIFYING INFORMATION)	ID PREFIX TAG	PROVIDER'S PLAN OF CORRECTION (EACH CORRECTIVE ACTION SHOULD BE CROSS-REFERENCED TO THE APPROPRIATE DEFICIENCY)	(X5) COMPLETE DATE
(C 000)	Initial Comments  This report is of a Followup Survey done by Bob Getchell on February 4, 2015.  The followup survey revealed that all deficiencies are not corrected, therefore a new plan of correction is required.	(C 000)		
(C 101)	Existing Licensed Fac- No less than '71 Rules  SECTION .0300 - PHYSICAL PLANT 10A NCAC 13F .0301 APPLICATION OF PHYSICAL PLANT REQUIREMENTS The physical plant requirements for each adult care home shall be applied as follows: (2) Except where otherwise specified, existing licensed facilities or portions of

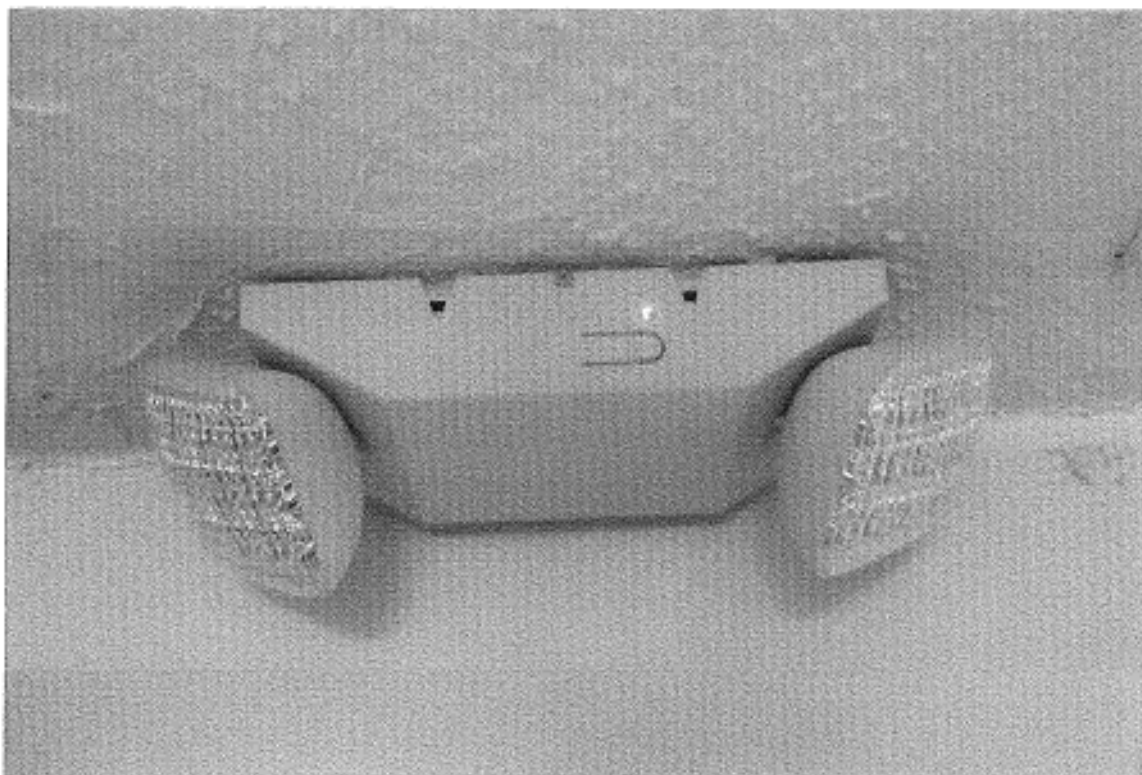
8/21-2015

(X4) ID PREFIX TAG	SUMMARY STATEMENT OF DEFICIENCIES (EACH DEFICIENCY MUST BE PRECEDED BY FULL REGULATORY OR LSC IDENTIFYING INFORMATION)	ID PREFIX TAG	PROVIDER'S PLAN OF CORRECTION (EACH CORRECTIVE ACTION SHOULD BE CROSS-REFERENCED TO THE APPROPRIATE DEFICIENCY)	(X5) COMPLETE DATE
{C 189}	Continued From page 2  near rooms 106 and 120 were approximately 123 feet apart so therefore will not provide adequate illumination if needed during a power outage.  7. The door from the medication preparation room to the corridor was cut into 2 pieces like a Dutch type door. There was no latch provided on the top section to hold the door tightly closed to be resistant to the passage of smoke and there was a significant gap where the sections of the door meet. When the door is replaced, it may be a Dutch type door if both halves of the door are provided with latches that will automatically latch when the door is closed and if an astragal is provided where the 2 halves meet to make that junction resistant to the passage of smoke.  8. The heat detector provided in the basement diaper room was hanging by the wires. Properly mount the heat detector to the ceiling	{C 189}

8. Heat detector was properly mounted. I have included a picture
