STATEMENT OF DEFICIENCIES AND PLAN OF CORRECTION

03/01/2016

AJINDA FAMILY CARE HOME II

1359 SUTTON ROAD
LOUISBURG, NC 27549

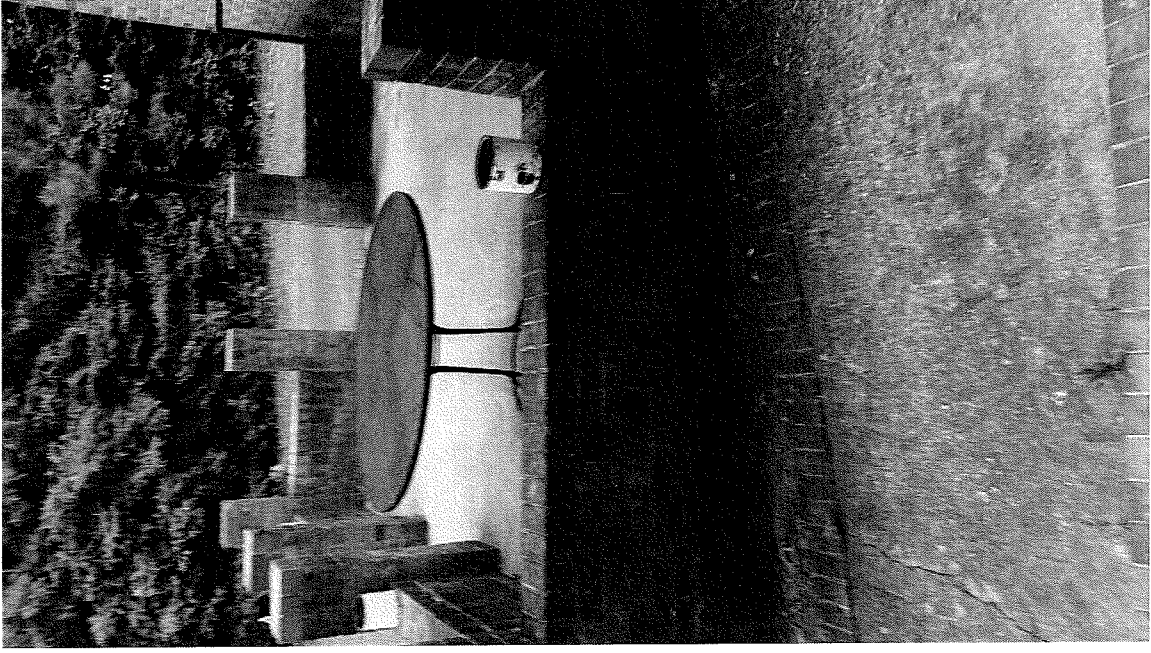
Picture/Attachment I

C 149	<p>Outside Entrances/Exits-Handrails At Porches</p> <p>SECTION .0300 - THE BUILDING 10A NCAC 13G .0312 OUTSIDE ENTRANCE AND EXITS</p> <p>(f) All steps, porches, stoops and ramps shall be provided with handrails and guardrails.</p> <p>This Rule is not met as evidenced by:</p> <p>1. Observations revealed a concrete patio at the rear of the facility. The patio has a ramp and two sets of steps leading from the patio. There is also a set of steps leading from the garage to the patio. None of the steps nor the ramp have handrails. Have a qualified technician install handrails either side of the ramp and stairs. Provide documentation of the repairs in the form of photos, receipts or work orders.</p> <p>2. Observations revealed a set of steps leading from the kitchen hall to the garage floor. Previously, the garage was not accessible to the Residents. A pool table has been installed in the garage for the Residents' use and, therefore, the steps are now being utilized and will need handrails. Have a qualified technician install handrails at the steps leading to the garage. Provide documentation of the repairs in the form of photos, receipts or work orders.</p>	C 149	<p>There's a wall beside the ramp with pillars that can be used as the handrail for the ramp. The wall is from 24" to 32" running along side the ramp. The wall can be used as a handrail for support and to break any potential falls. See Picture 1.</p>
