SUBJECT: Corrective Actions resulting from DHSR
Construction Section Biennial Survey 6-28-19. for
Trinity Oaks Assisted Living License # HAL 080010.

STATEMENT OF DEFICIENCIES AND PLAN OF CORRECTION	(X1) PROVIDER/SUPPLIER/CLIA IDENTIFICATION NUMBER: HAL080010	(X2) MULTIPLE CONSTRUCTION A. BUILDING: 1D B. WING: _____	(X3) DATE SURVEY COMPLETED 06/28/2019
--	---	---	--

RE: HA Biennial Survey (6/28/2019)
Trinity Oaks Continuing Care
728 Klumac Road
Salisbury (Rowan County)
FID # 931257; HA 1080010

CEILING REMEDIATION

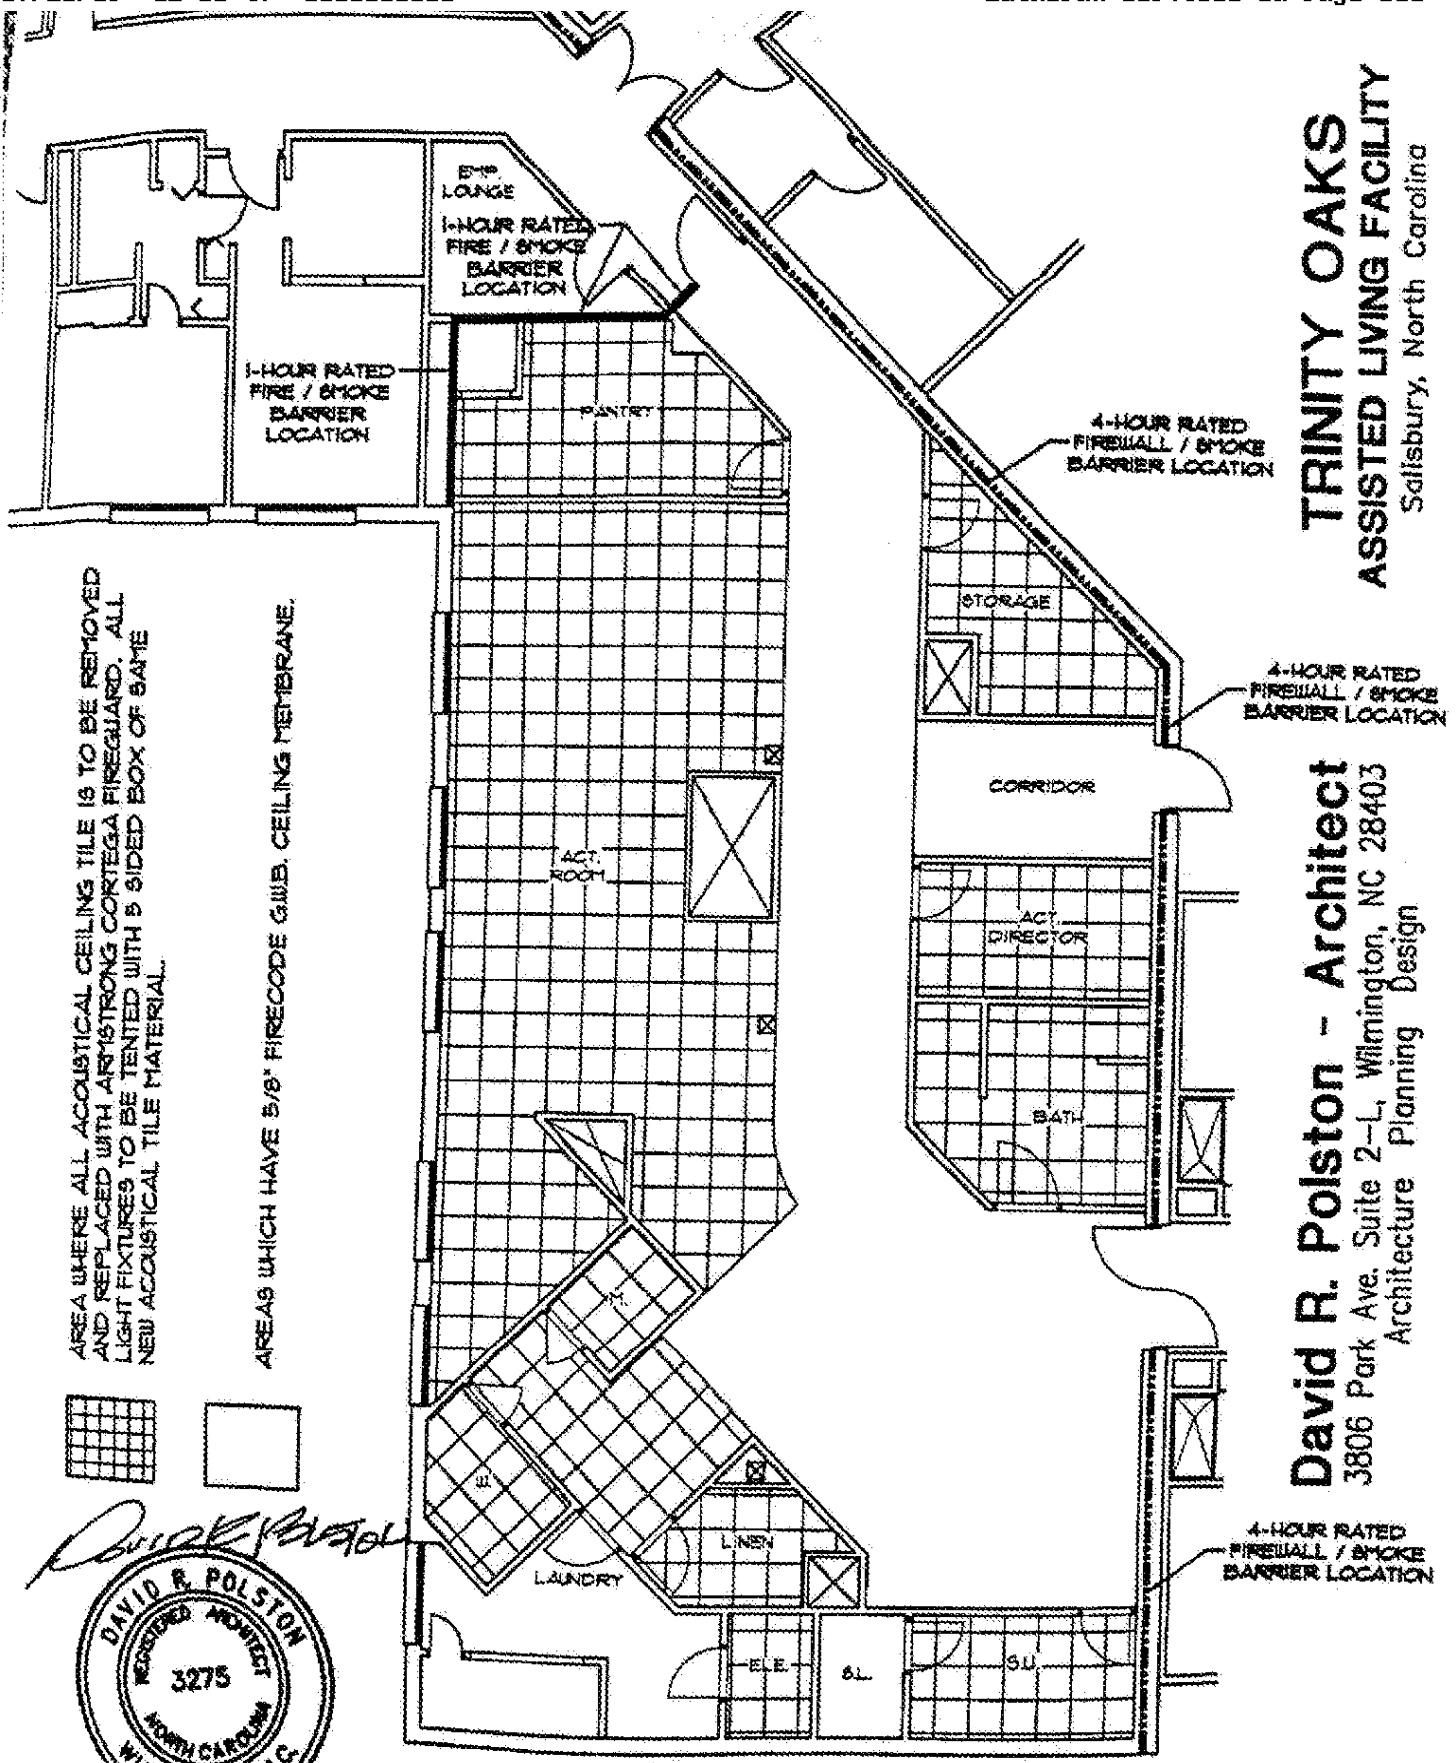
FLOOR PLAN
SCALE: 3/32" = 1'-0"

I visited the facility to document the existing conditions. Similar to your findings, the ceiling tiles do not have a UL stamp or complied with the 1.0 LBS/SF weight. The ceiling grid appears to be the original steel rated grid similar to Armstrong Prelude XL fire rated grid. The recessed light fixtures were not boxed with rated acoustical tile material. It does appear that the HVAC supply and return grills have listed radiation dampers which were integral to the steel grill box.

I was also able to review the 1991 construction drawings prepared by Calloway Moore and Johnson. The documents indicated that the roof/ceiling assembly for this area to be one hour rated and also appears that UL L209 was the basis of design. UL L209 matches the existing field conditions except for the rated ceiling tiles and protection of the light fixtures.

Based on my on-site observations, review of the original construction drawings and review of the UL assembly components, it appears that ceiling tiles must be replaced and the light fixtures protected. Attached is a floor plan of the "Old Wing" identifying the areas for tile replacement. The UL L209 lists Armstrong tiles as an acceptable manufacturer. We have instructed the owner

to replace all acoustical ceiling tile with Armstrong Cortega Fireguard (Item #824). This tile is tested for the 1 Hour assembly and weighs 1.09 LBS/SF. I have also instructed the owner to tent the light fixture with a 5 sided box constructed of the same Armstrong Cortega Fireguard. The tenting of the light fixture with the acoustical material complies with UL 1209 requirements.

AREA WHERE ALL ACOUSTICAL CEILING TILE IS TO BE REMOVED AND REPLACED WITH ARMSSTRONG CORTEGA FIREGUARD. ALL LIGHT FIXTURES TO BE TENTED WITH 5 SIDED BOX OF SAME NEW ACOUSTICAL TILE MATERIAL.
