Fax Cover Sheet

RE: Uwharrie Family Care Home – FC Biennial Survey

FID #930127

STATEMENT OF DEFICIENCIES AND PLAN OF CORRECTION	(X1) PROVIDER/SUPPLIER/CLIA IDENTIFICATION NUMBER: FCL076037	(X2) MULTIPLE CONSTRUCTION A. BUILDING: 01 B. WING _____	(X3) DATE SURVEY COMPLETED 09/13/2023
--	--	---	---

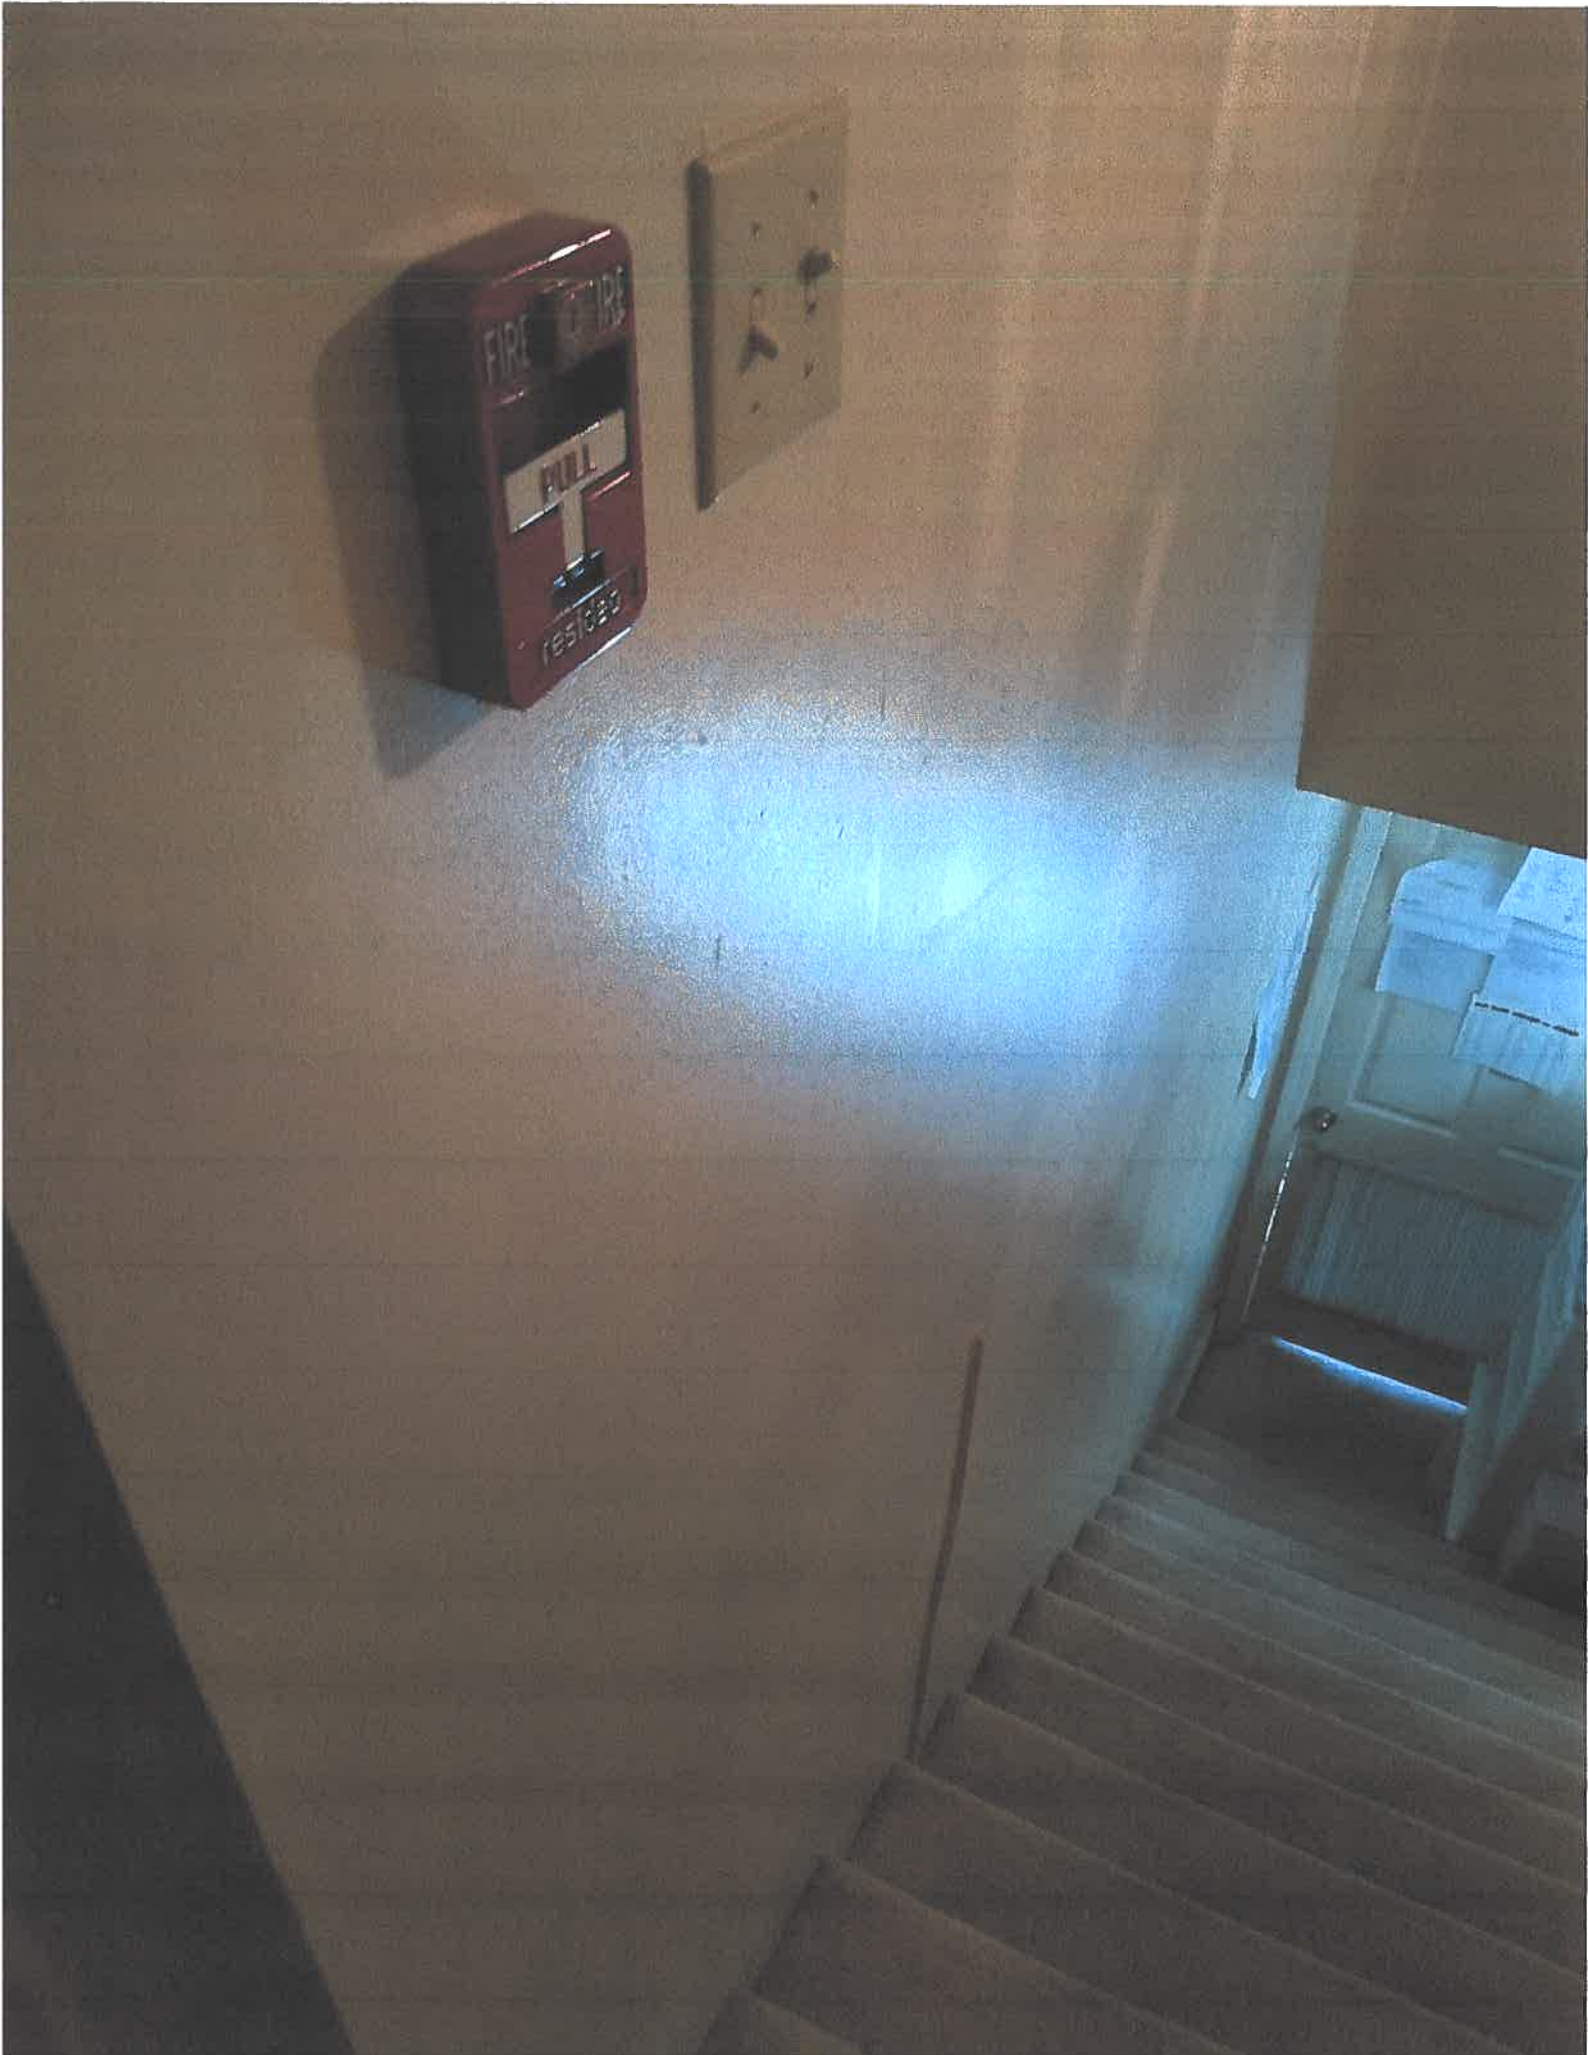
✓ This Rule is not met as evidenced by:
1. At the time of the survey it was observed that house had an upstairs level and a basement level but did not have an addressable fire alarm installed in the house. This is not compliant with the rule. Take the necessary steps to install a building fire alarm system in accordance with NFPA 72. Provisions must be made to activate the internal evacuation alarm at all required exits.

Pull station installed on second level.

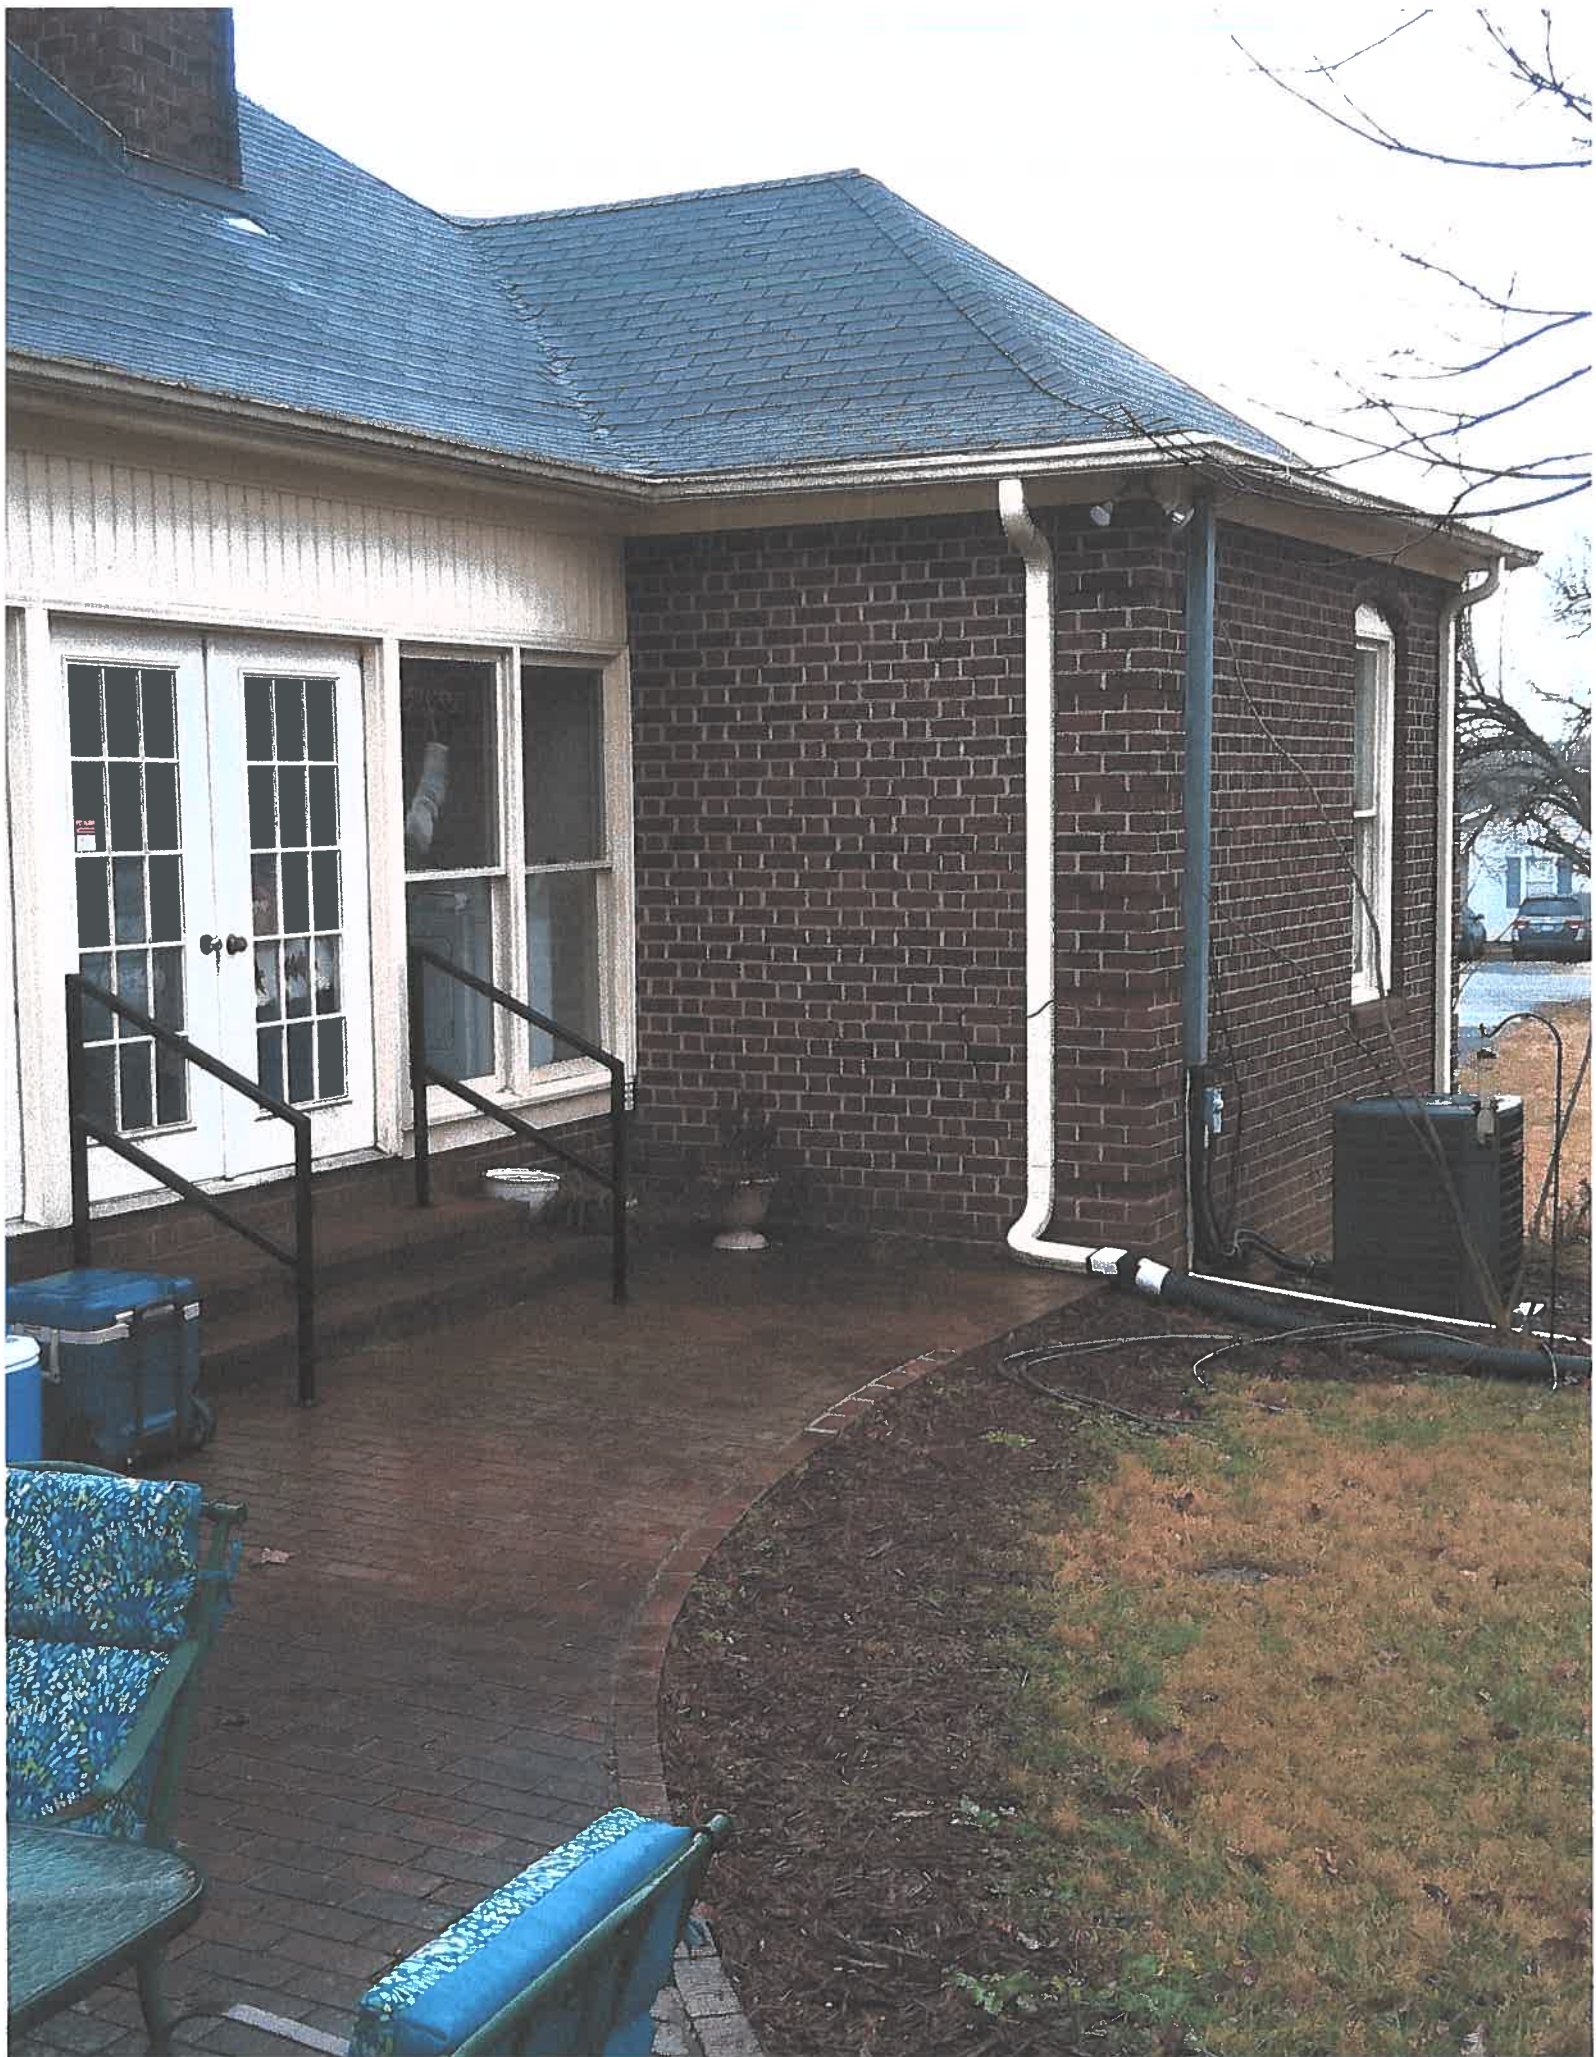
C 149	Outside Entrances/Exits-Handrails At Porches SECTION .0300 - THE BUILDING 10A NCAC 13G .0312 OUTSIDE ENTRANCE AND EXITS (f) All steps, porches, stoops and ramps shall be provided with handrails and guardrails. This Rule is not met as evidenced by: 1. At the time of the survey it was observed that the rear steps did not have handrails provided. This is not compliant with the rule. Take the necessary steps to provide handrails on both sides of the steps.	C 149	Vance DAVIS Hand rails have been installed.	
C 174	Building Equipment Maintained Safe, Operating SECTION .0300 - THE BUILDING 10A NCAC 13G .0317 BUILDING SERVICE EQUIPMENT	C 174
