Division of Health Service Regulation

**CREEKSIDE GROUP HOME**

DHSR Survey for Watauga Opportunities Creekside Group Home

Survey done on 8/13/2025

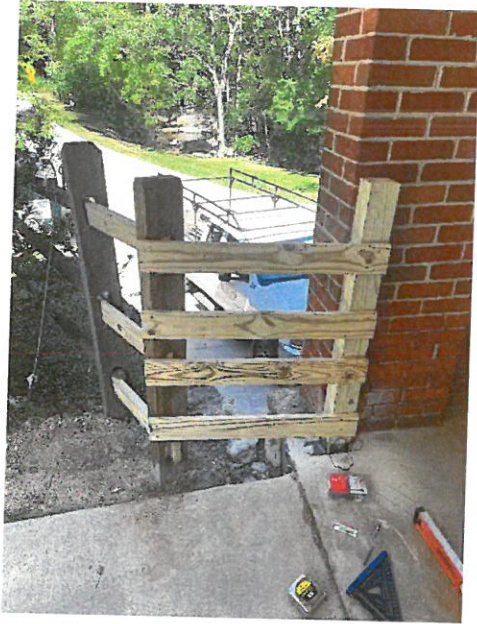
| (X4) ID<br>PREFIX<br>TAG | SUMMARY STATEMENT OF DEFICIENCIES<br>(EACH DEFICIENCY MUST BE PRECEDED BY FULL<br>REGULATORY OR LSC IDENTIFYING INFORMATION) | ID<br>PREFIX<br>TAG | PROVIDER'S PLAN OF CORRECTION<br>(EACH CORRECTIVE ACTION SHOULD BE<br>CROSS-REFERENCED TO THE APPROPRIATE<br>DEFICIENCY) | (X5)<br>COMPLETE<br>DATE |
|---|---|---|---|---|
| V 736 | <p>Continued From page 1</p> <ul style="list-style-type: none"> <li>-There was no safety barrier for a 2.5' wide open space between the carport and an adjacent fence which bordered an 8.5' vertical drop to the lower concrete driveway.</li> <li>-Two beige-colored water stains on the white ceiling above the kitchen sink. One stain was approximately 6" in length. The other stain was approximately 8" in diameter.</li> <li>-A section of the ceiling approximately 12" by 3" located directly above the shower in bathroom #1 had numerous gray stains which appeared as irregularly shaped splotches of varying shapes and sizes.</li> <li>-The exhaust fan/light fixture in bathroom #1 was covered with an accumulation of dust.</li> <li>-The toilet paper holder was missing from bathroom #1.</li> </ul> <p>Interview on 8/13/25 with Client #1 revealed:<br/>-She had not noticed the open space between the carport and the fence. "What hole? I don't see it now."</p> <p>Observation and attempted interview on 8/13/25 at approximately 1:21 pm with Client #2 revealed:<br/>-He did not provide any information regarding the absence of a safety barrier between the carport and fence. When interviewed, he offered no response, avoided eye contact, and instead focused his attention on the television while repeatedly checking his watch.</p> <p>Interview on 8/13/25 with Client #3 revealed:<br/>-On 8/13/25, a construction worker placed a safety barrier between the carport and fence, "I saw wood boards. A worker (construction crew) from downstairs put it there. I don't remember what was there before. I don't know why it's there."</p> | V 736 | <p>Temporary repair was completed as per the plan of protection as per page 4 of this document at 1 pm on 8/13/25. The permanent fix with a new fence anchored to the concrete drive and concrete post to the ground was completed on 8/27/25 by the contractor. Please see attached picture for proof of permanent fence completion. Potential hazards has been added to the monthly safety inspection performed by the Residential Coordinator and/or QP. In the case of abnormal events such as natural disaster, there will be a post-event inspection when can be safely performed by the QP and safety committee chairperson or designees. During any construction projects, the Residential Coordinator and/or QP will inspect weekly for potential safety hazards.</p> <p>The two beige-colored water stains on the ceiling was a result of water damage from Hurricane Helene. Repairs from the water damage on the upstairs level are included in the current Helene Repair construction cited in the report. The construction is scheduled to be finished 1st half of September.</p> <p>The gray stains on the ceiling in bathroom #1 was fixed 8/14/2025. Please see attached pictures for proof of completion.</p> | |

| (X4) ID<br>PREFIX<br>TAG | SUMMARY STATEMENT OF DEFICIENCIES<br>(EACH DEFICIENCY MUST BE PRECEDED BY FULL<br>REGULATORY OR LSC IDENTIFYING INFORMATION) | ID<br>PREFIX<br>TAG | PROVIDER'S PLAN OF CORRECTION<br>(EACH CORRECTIVE ACTION SHOULD BE<br>CROSS-REFERENCED TO THE APPROPRIATE<br>DEFICIENCY) | (X5)<br>COMPLETE<br>DATE |
|---|---|---|---|---|
| V 736 | <p>Continued From page 3</p> <p>Interview on 8/13/25 with the Chief Executive Officer (CEO) revealed:</p> <ul style="list-style-type: none"> <li>-A bush was previously located along the upper-level driveway of the facility, between the carport and the adjacent fence.</li> <li>-The bush was removed some time between 7/1/25-8/13/25 by a construction crew conducting storm damage repairs to the lower level of the facility.</li> <li>-The hedge was removed to provide access to underground utility lines during the repair work.</li> <li>-2' x 4' boards would be placed to serve as a temporary barrier until a permanent fixture could be installed.</li> </ul> <p>Interview on 8/13/25 with the Construction Crew Supervisor revealed:</p> <ul style="list-style-type: none"> <li>-"While looking for an underground fuel tank and lines, we removed a bush to access the lines that fed to the basement (facility). It was within the past 2 weeks or so."</li> </ul> <p>Review on 8/13/25 of a Plan of Protection completed and submitted by the QP/COO on 8/13/25 revealed:</p> <ul style="list-style-type: none"> <li>- "What immediate action will the facility take to ensure the safety of the consumers in your care? Watauga Opportunities (Licensee) CEO immediately had contractors (who are working on-site) secure three boards across the opening at the end of the carport and the fencing to prevent access. This is a temporary repair until completion of construction of a permanent barrier. This repair was completed at 1 pm on the same day the issue was identified (8/13/2025) and will prevent any possible fall. Describe your plans to make sure the above happens.</li> </ul> <p>As of today 8/13/25, the opening is blocked with a temporary construction fence. The permanent fix</p> | V 736 | | |

| (X4) ID<br>PREFIX<br>TAG | SUMMARY STATEMENT OF DEFICIENCIES<br>(EACH DEFICIENCY MUST BE PRECEDED BY FULL<br>REGULATORY OR LSC IDENTIFYING INFORMATION) | ID<br>PREFIX<br>TAG | PROVIDER'S PLAN OF CORRECTION<br>(EACH CORRECTIVE ACTION SHOULD BE<br>CROSS-REFERENCED TO THE APPROPRIATE<br>DEFICIENCY) | (X5)<br>COMPLETE<br>DATE |
|---|---|---|---|---|
| V 736 | <p>Continued From page 4</p> <p>will be a permanent fence at the completion of construction which is some time in September (2025). At no time will the space be open. Group home staff will be required to immediately report any potential hazards. The potential hazards will be added to the monthly safety inspection performed by Residential Coordinator and/or QP (QP/COO). In addition, the QP (QP/COO) or designated program director will conduct quarterly safety inspection of both homes with the safety committee chairperson or designated safety committee member. In the case of any abnormal events (such as natural disaster), there will be a follow-up inspection when can be safely performed by the QP (QP/COO) and safety committee chairperson or designees."</p> <p>The facility served clients with diagnoses which included Moderate to Severe Intellectual Disabilities; Ataxic Cerebral Palsy, Intermittent Explosive Disorder, Parkinsonism, Unspecified Dementia, Neurocognitive Disorder with Lewy Bodies, Osteoarthritis, Major Depressive Disorder, and Other Specified Congenital Deformities of Feet. During observation on 8/13/25 at the main level of the facility, there was a 2.5' wide open space between the carport and an adjacent fence which led to an 8.5' vertical drop to the paved driveway on the lower level. There was no safety barrier or protective measure in place to prevent falls from the main level to the lower level.</p> <p>This deficiency constitutes a Type A2 rule violation for substantial risk of serious harm and must be corrected within 23 days.</p> | V 736 | | |

*The permanent fix with a new fence anchored to the concrete drive and concrete post to the ground was completed on 8/27/25 by the contractor. Please see attached picture for proof of permanent fence completion.*
