Exempt from Review – Replacement Equipment

Record #: 3455
Date of Request: December 15, 2020
Facility Name: Carolinas HealthCare System Imaging-Kannapolis
FID #: 061206
Business Name: Union Medical Services, LLC
Business #: 1915
Project Description: Replace existing CT scanner
County: Cabarrus

RE: Exemption Request for Union Medical Services, LLC d/b/a Carolinas HealthCare System Imaging – Kannapolis to Replace its Existing CT Scanner

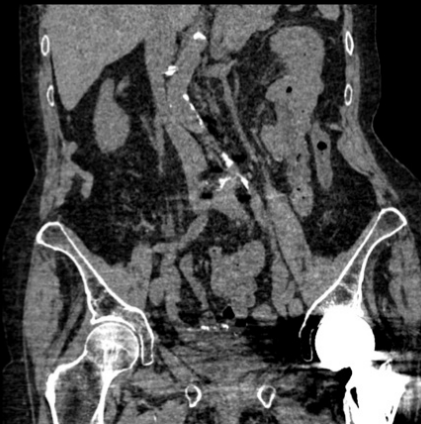
Without Smart MAR

Metal artifact reduction. Both in single and dual energy.

and streak artifacts caused by metal in the body, such as hip implants, surgical clips, endovascular coils, and dental fillings. Smart MAR requires one single kV scan and can be enabled in secondary reconstructions, making the metal artifact reduction workflow fast and efficient.

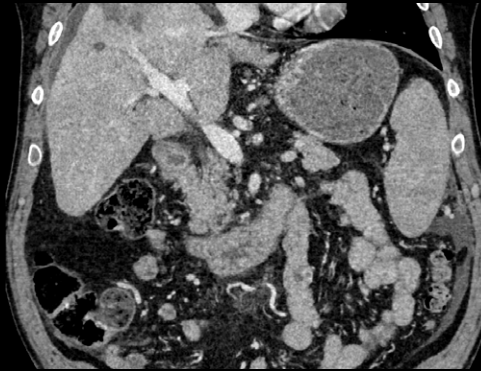
0.625 mm ASiR-V 50%  
Iterative Reconstruction  
2008 - 2018

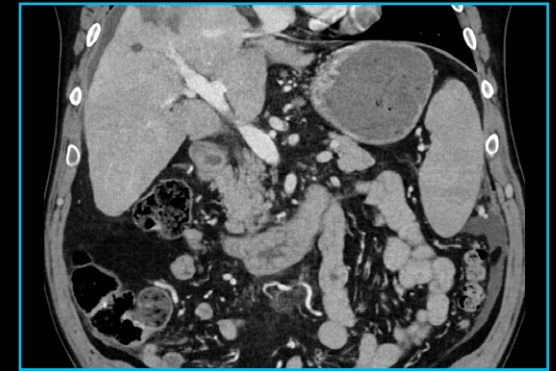
0.625 mm TrueFidelity  
TrueFidelity Images  
2018 - Future

Generated by our Deep Learning Image Reconstruction, TrueFidelity Images are created using artificial intelligence to combine the low-dose of iterative reconstruction with the "classic-looking" image texture of FBP.

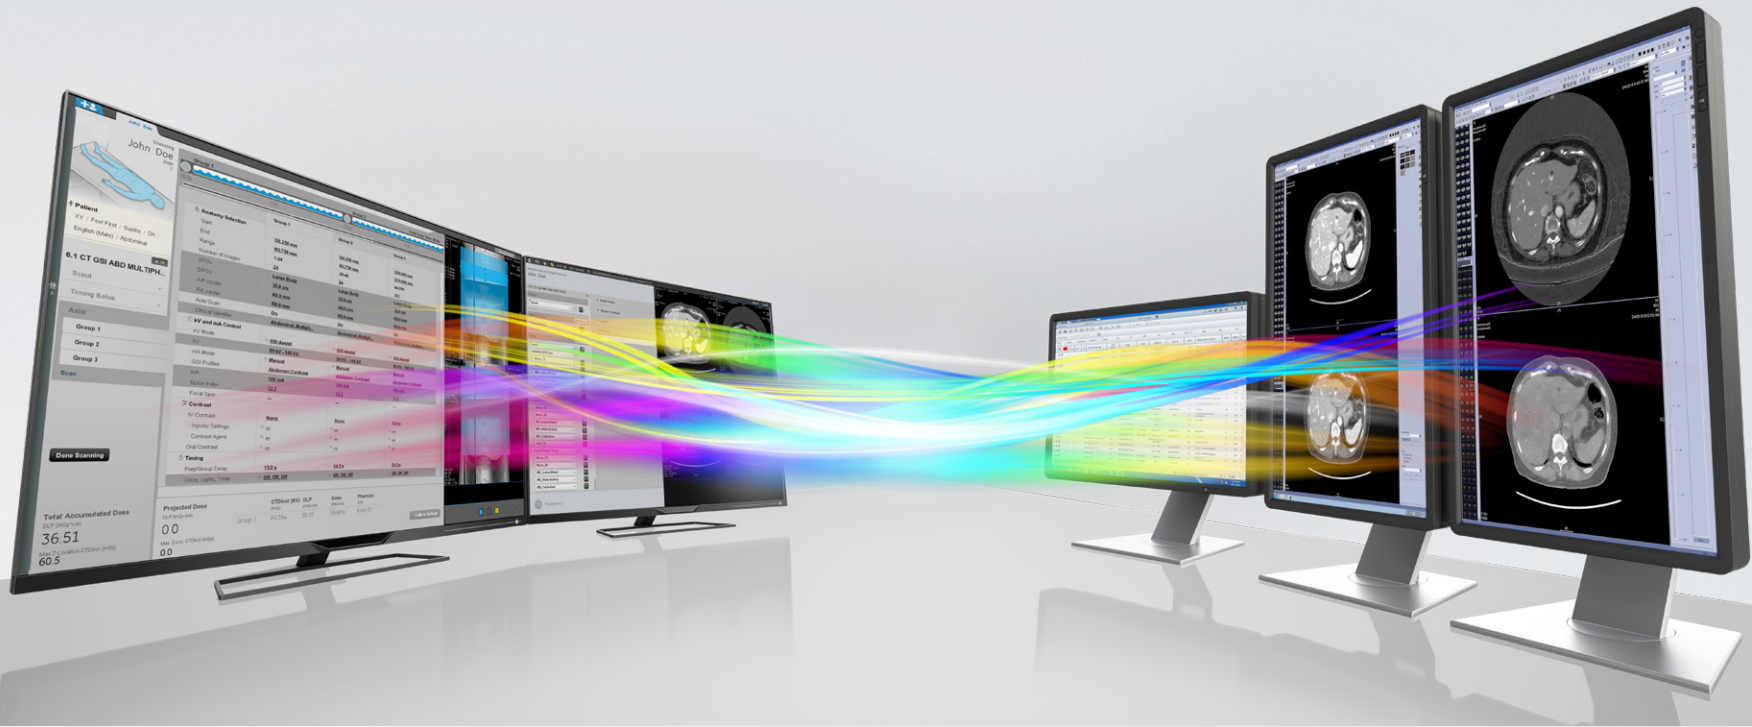
# Volume. Spectral. Simplified.

GSI Xtream extends to our Revolution Apex platform with its wide collimation and 50 cm FOV to deliver the only volume spectral CT. Enabled by ultrafast kV switching, you can scan more challenging patients and reduce the effects of motion. With a simplified workflow you can make part of your daily practice. From setup to post-processing, GSI Xtream is as intuitive as a single energy exam. These improvements, combined with native GSI reconstruction, deliver volume spectral CT workflow that's twice as fast. GSI Xtream helps you diagnose disease with more confidence, which could ultimately put patients on the right treatment path sooner.

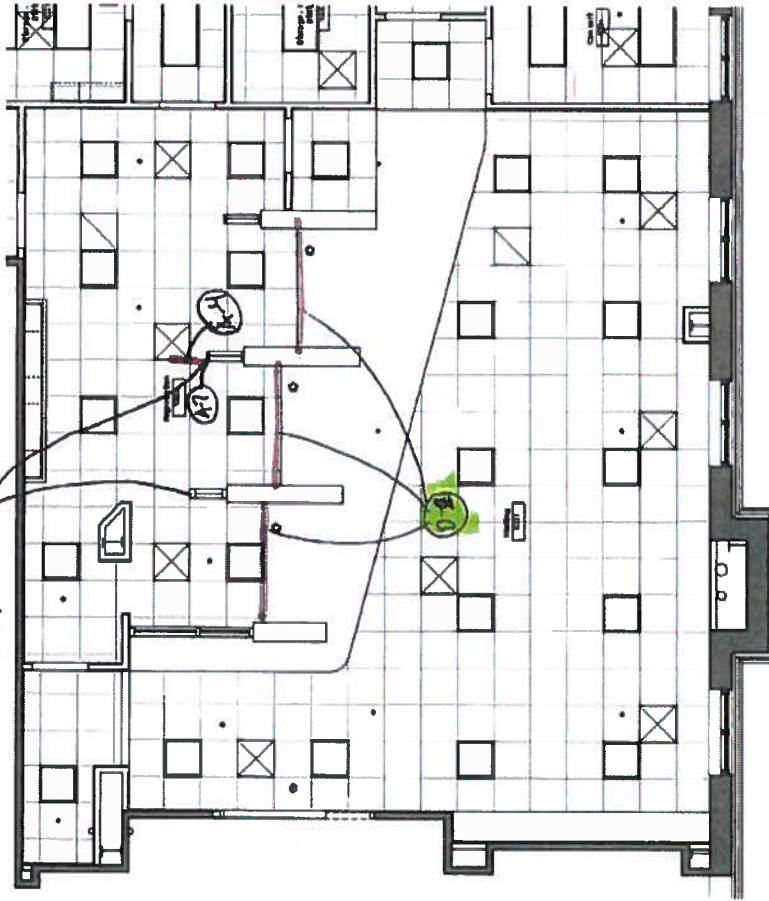
FINISH GYP 02  
WALL, SEE PHOTO
