SUBJECT: Corrective Actions resulting from DHSR
Construction Section Biennial Survey 6-28-19. for
Trinity Oaks Assisted Living License # HAL 080010.

STATEMENT OF DEFICIENCIES AND PLAN OF CORRECTION	(X1) PROVIDER/SUPPLIER/CLIA IDENTIFICATION NUMBER: HAL080010	(X2) MULTIPLE CONSTRUCTION A. BUILDING: 1D B. WING: _____	(X3) DATE SURVEY COMPLETED 06/28/2019
--	---	---	--

RE: HA Biennial Survey (6/28/2019)
Trinity Oaks Continuing Care
728 Klumac Road
Salisbury (Rowan County)
FID # 931257; HA 1080010

CEILING REMEDIATION

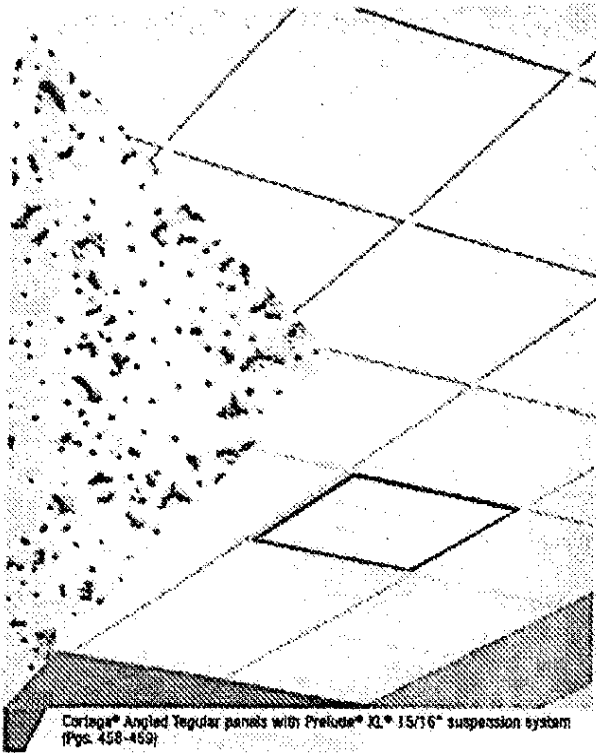
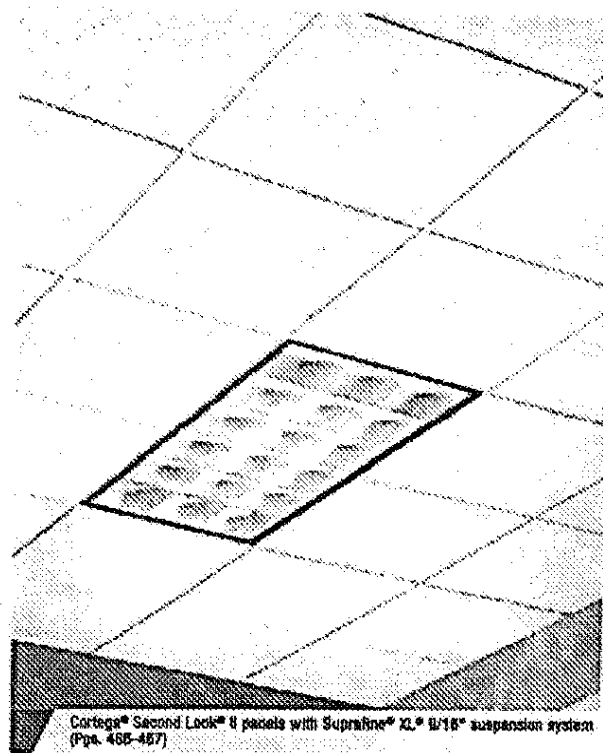
a. Old Wing - the facility is required to have a one-hour fire-resistance-rated roof/ceiling assembly to protect the noncombustible construction above. The existing acoustical ceiling tiles are not a part of an approved one-hour roof/ceiling assembly. These tiles are not marked with an UL or similar testing laboratory approval stamp. They are also not heavy enough. Provide an approved roof/ceiling assembly, assuring that the exit grid is acceptable with the new one-hour fire-resistance-rated roof/ceiling assembly and if not, replace grid. All penetration must be properly firestopped.
